**[Docket No. 2002-SW-14-AD; Amendment 39-13015; AD 2003-01-04]**

### **Airworthiness Directives; Bell Helicopter Textron, Inc. Model 204B, 205A, 205A-1, 205B and 212 Helicopters**

**2003-01-04 Bell Helicopter Textron, Inc.:** Amendment 39-13015. Docket No. 2002-SW-14-AD.

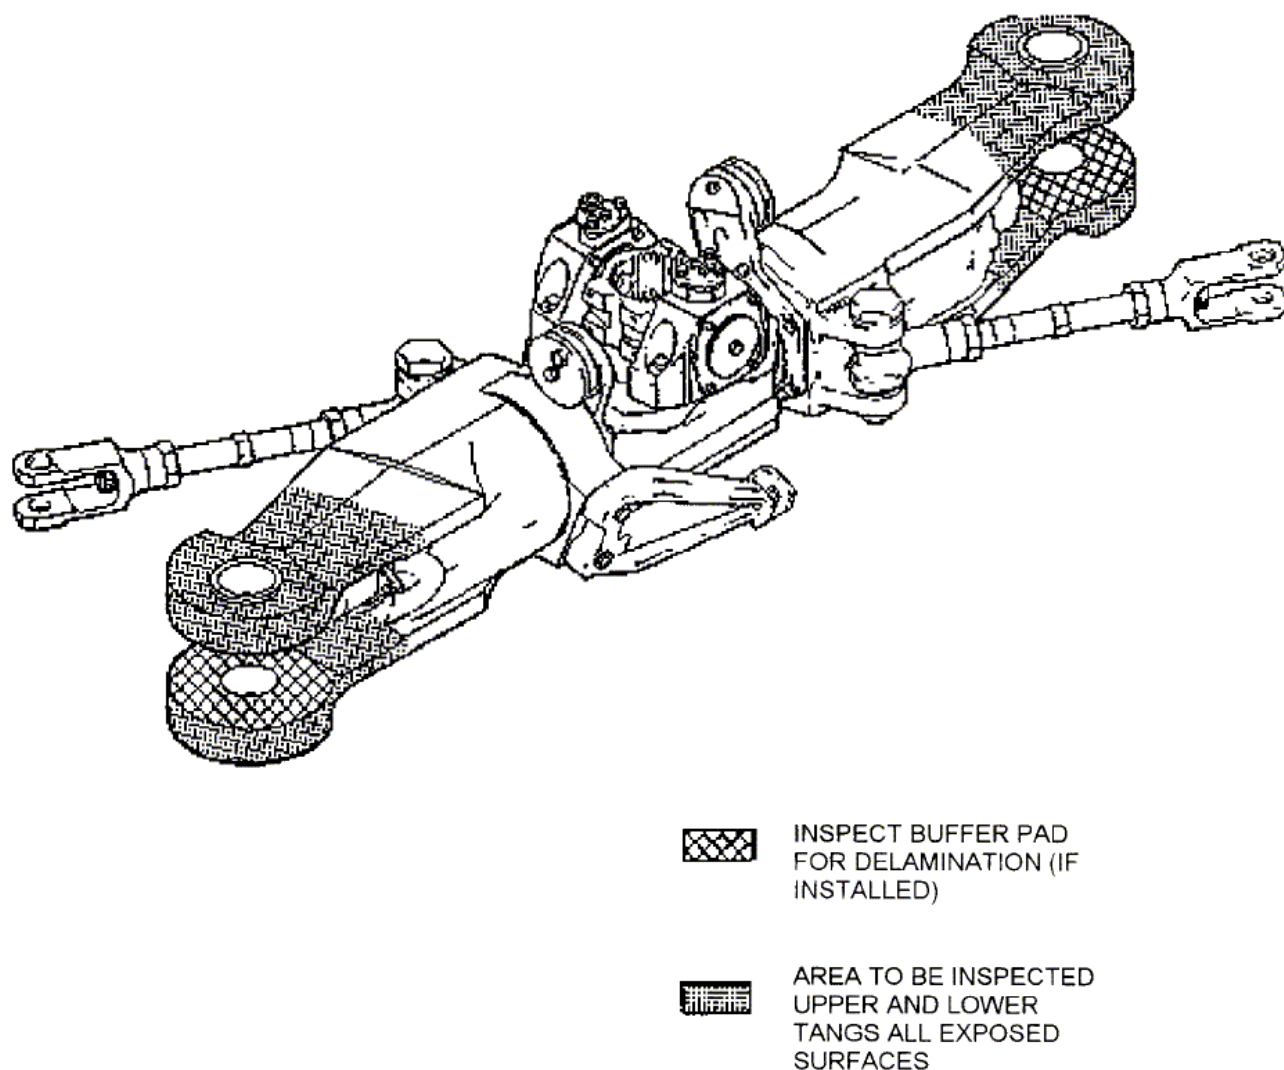
**Figure 1. Inspection of Main Rotor Hub Grip Tangs**

(2) Using a 10-power or higher magnifying glass, visually inspect the exposed surfaces of the upper and lower tangs of each grip for a crack. Pay particular attention to the lower surface of each lower grip tang from the main rotor blade bolt-bushing flange to the leading and trailing edge of each grip tang. See Figure 1 as follows:

- (1) Remove each main rotor blade, and
- (2) Inspect each grip buffer pad on the inner surfaces of each grip tang for delamination (see Figure 1 of this AD). If there is any delamination, remove the buffer pad and inspect the grip surface for corrosion or other damage.

- (f) Before further flight:
- (1) Replace with an airworthy grip any grip with a crack.
  - (2) Replace with an airworthy grip or repair, if within maximum repair damage limits, any grip with any corrosion or other damage.
